FY04 Forest Service Aviation Accident Review

NTSB Identification: **SEA04LA029.**

NTSB Identification: FTW04TA075.

NTSB Identification: SEA04TA147.

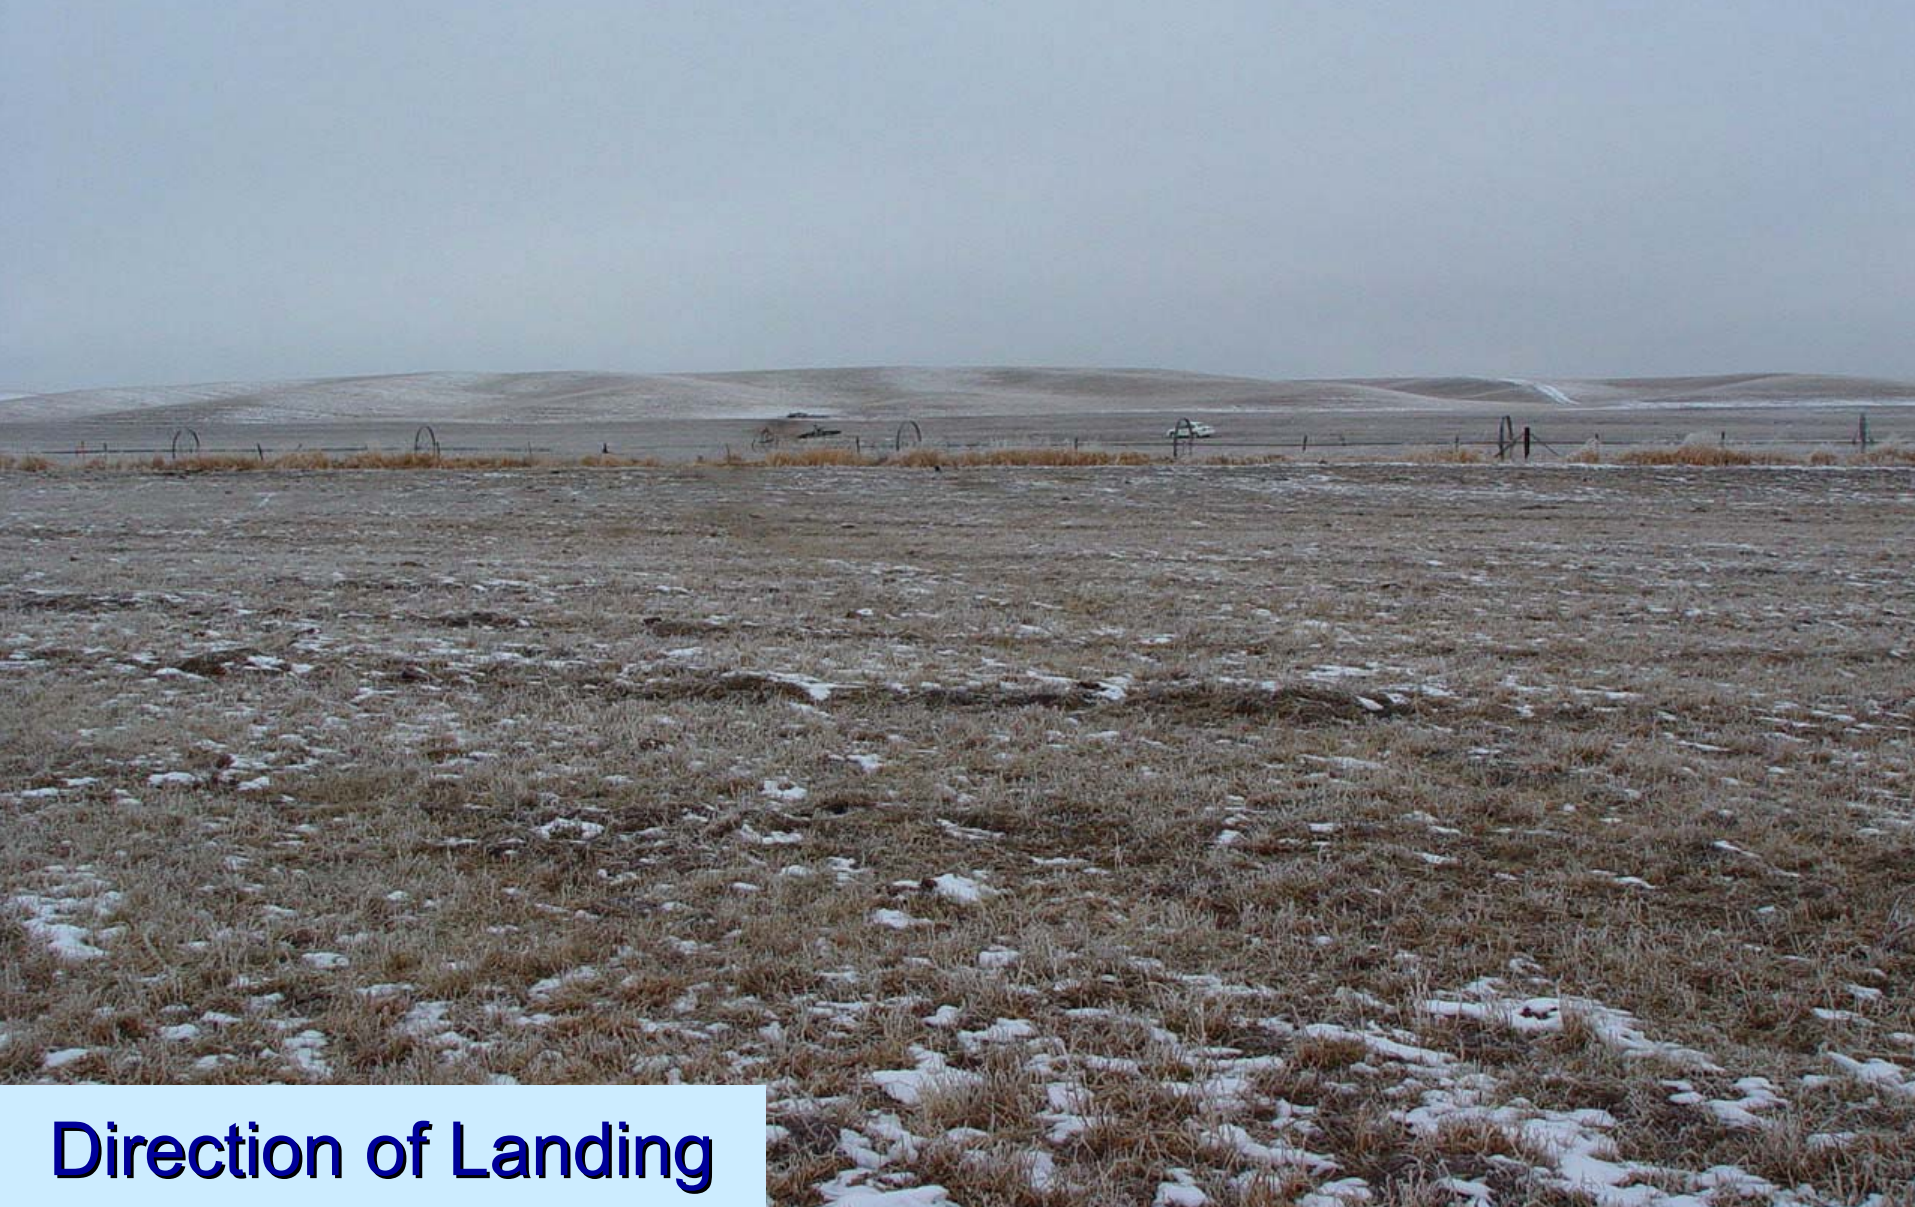
Direction of Landing

During the turn, a "thump" was felt and the right bank angle increased from about 25 degrees to 45 degrees. While the second pilot was attempting to correct from the increased bank angle, the aircraft at some point, entered a descent.

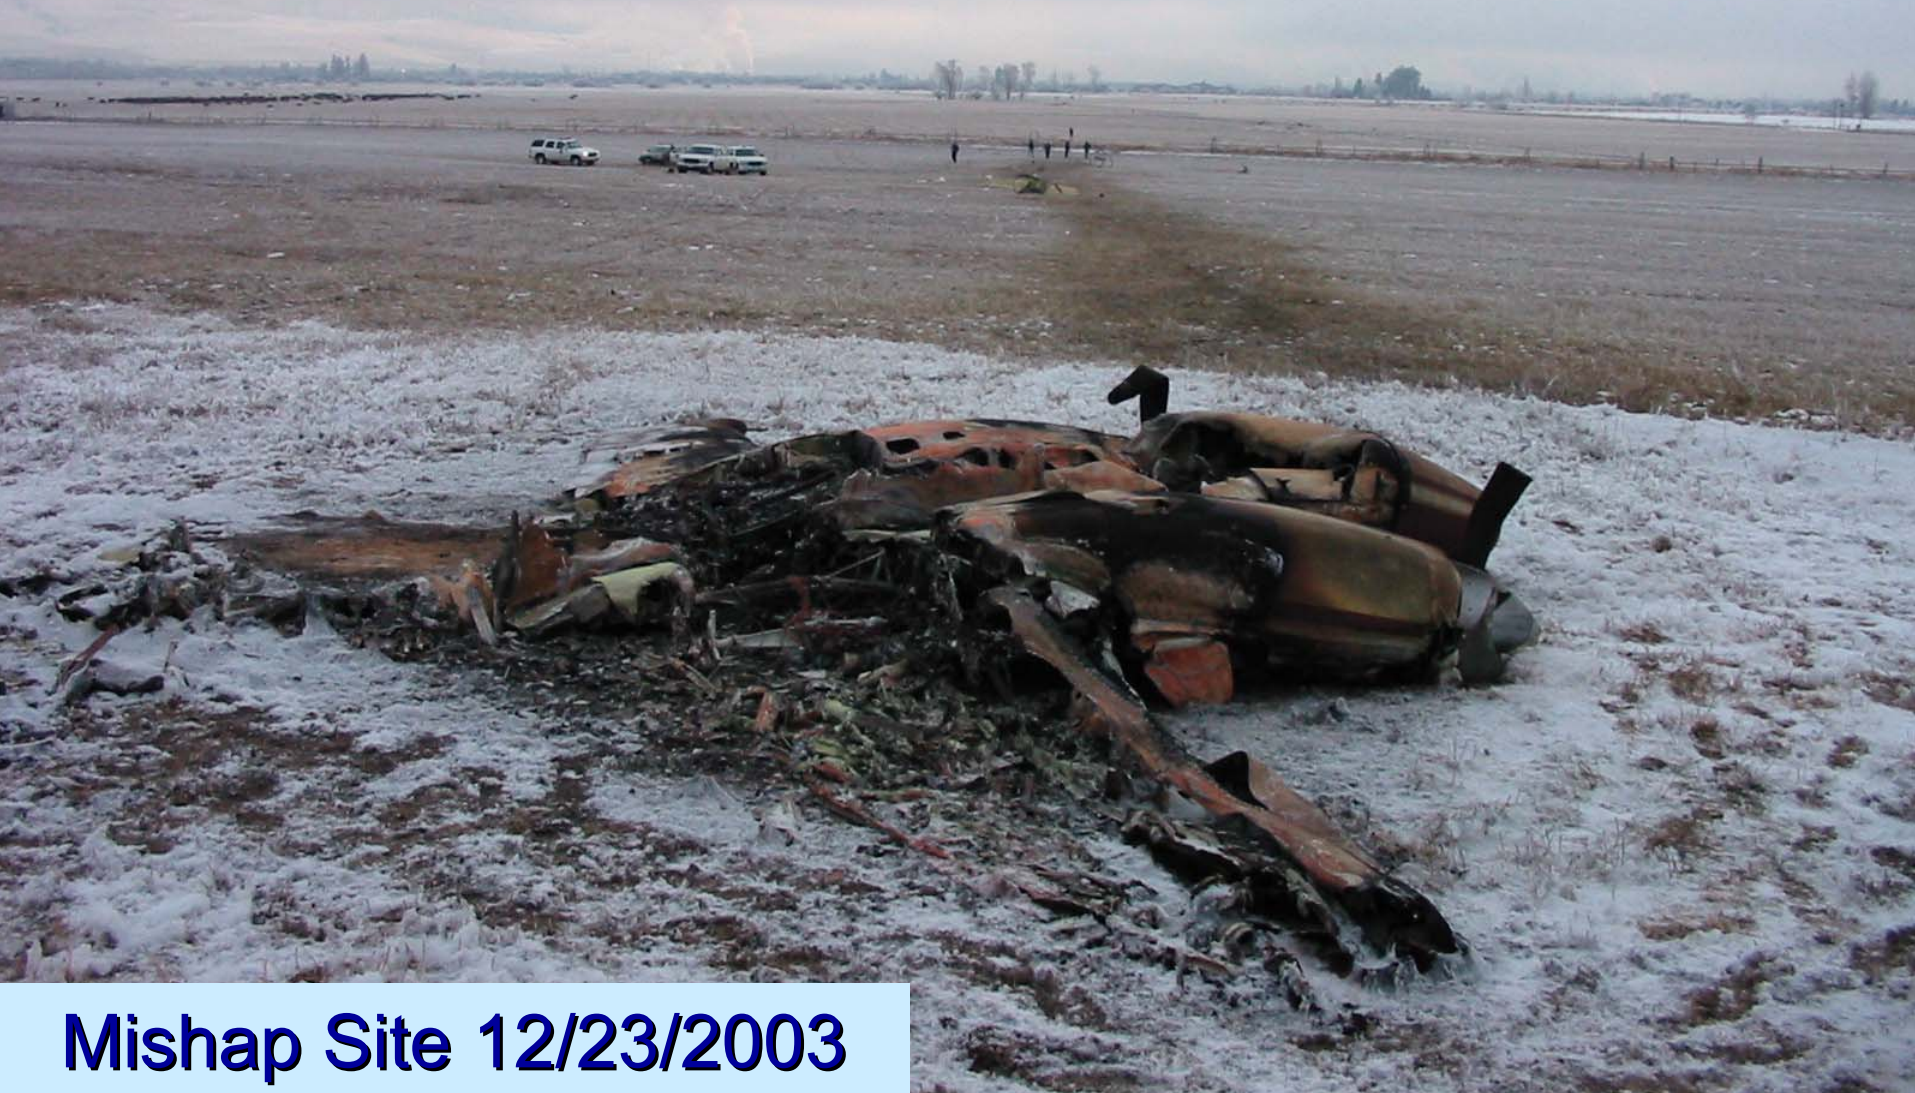
Mishap Site 12/23/2003

just before ground impact to open terrain about one mile south of the runway, the pilot-in-command took control of the aircraft to level the wings.

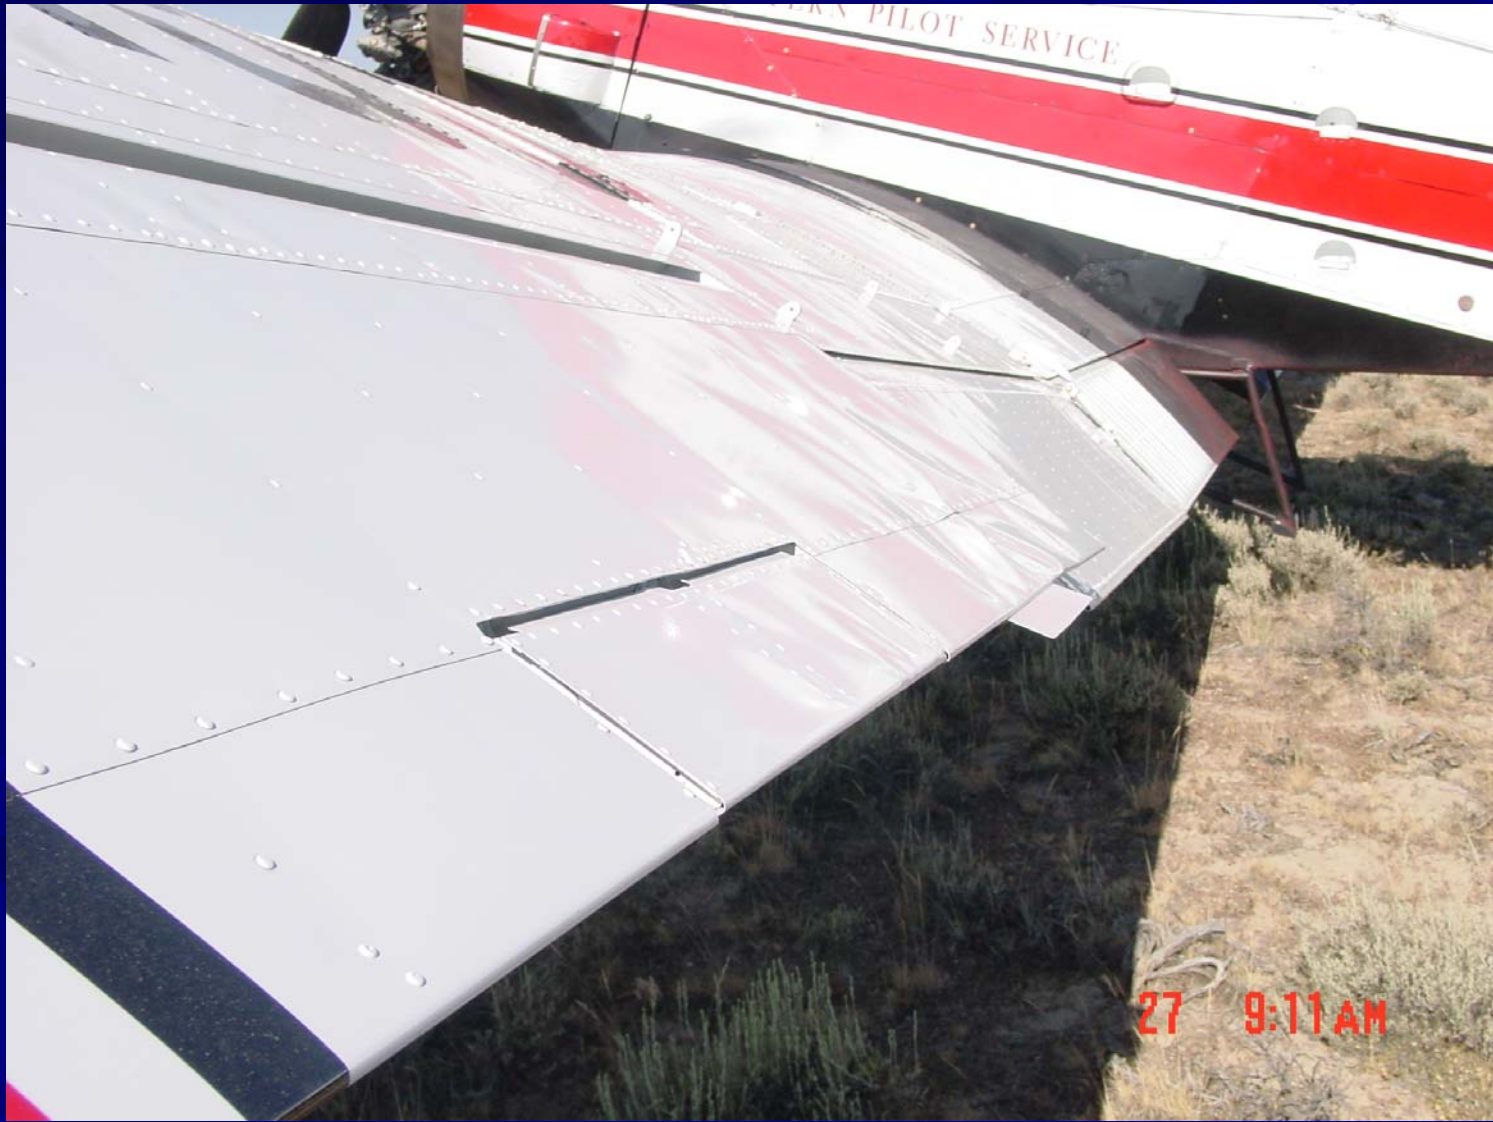
In order to land the airplane where he wanted to, he turned the fuel selector to the off position. During the landing roll, the left wing impacted a fence pole bending ribs and wrinkling the aileron.

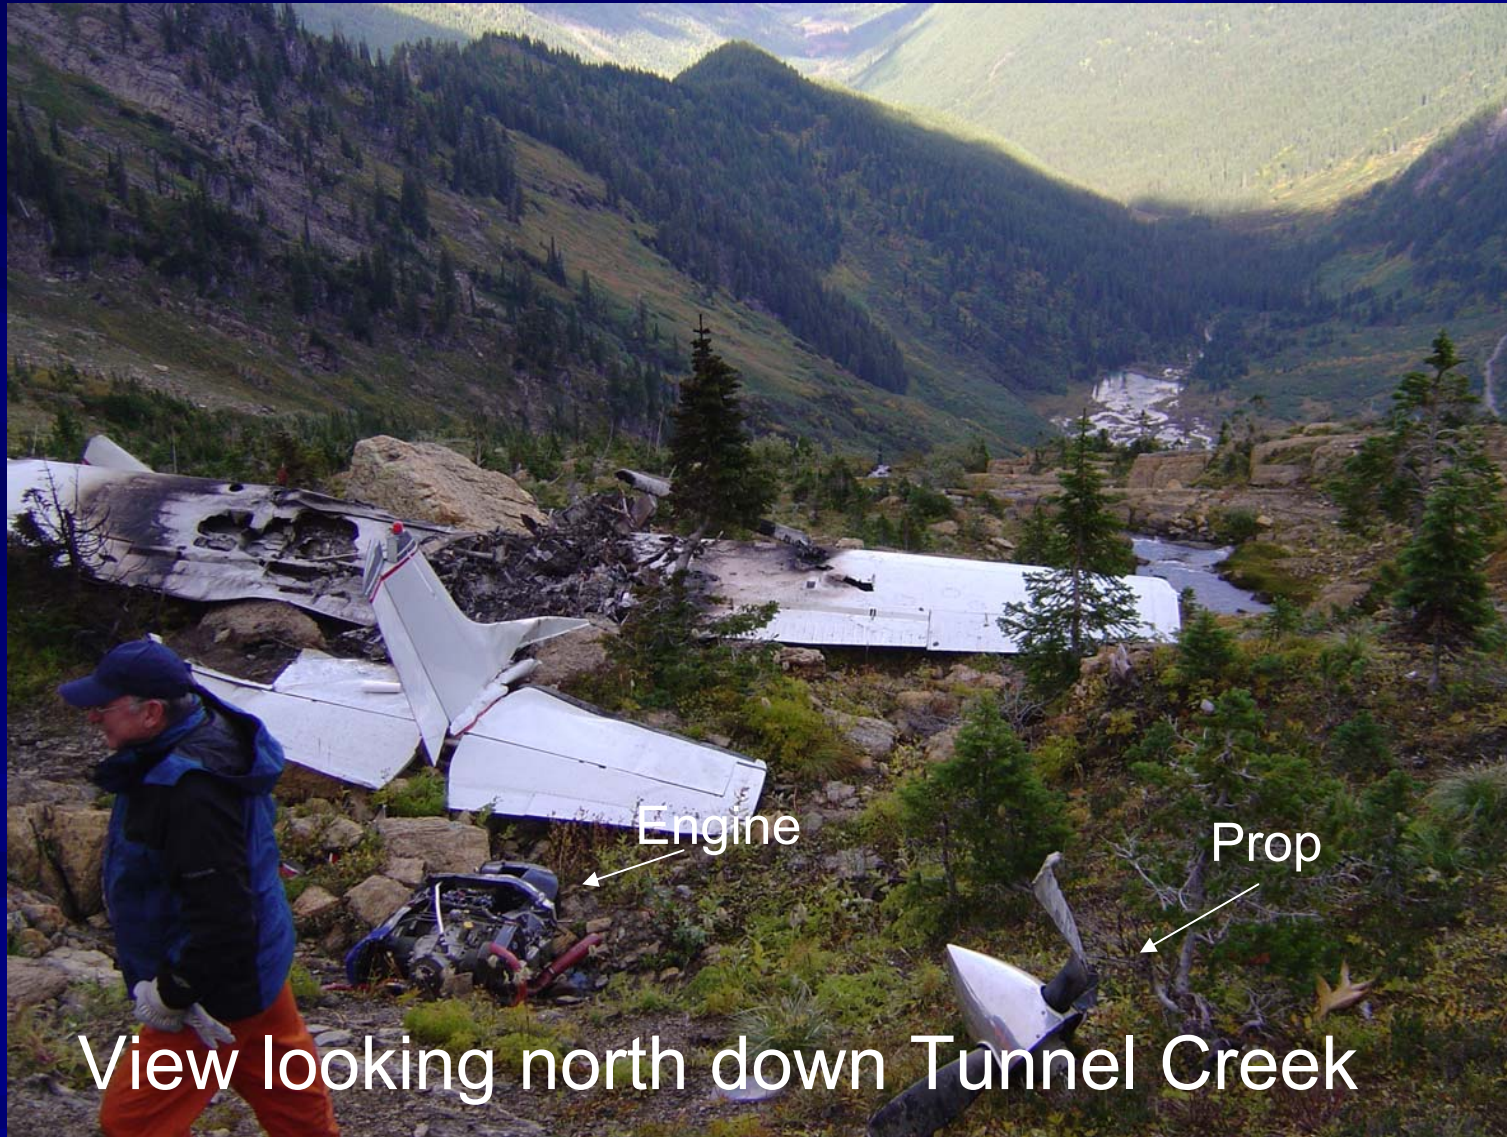
View looking north down Tunnel Creek

Approximate first ground contact
